SHEPHERD OF THE VALLEY LUTHERAN CHURCH

TRUSS CONDITION ASSESSMENT

December 2020

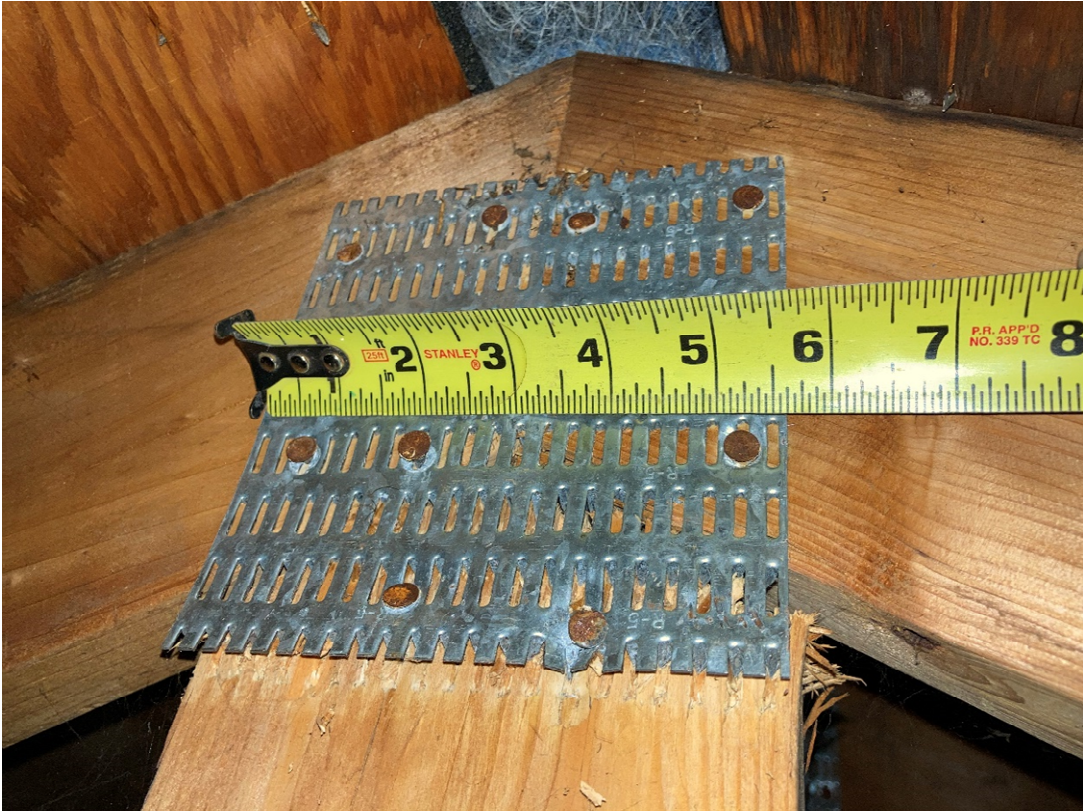
The truss connections were typical truss plate connectors, Mitek or similar, and rely on the 'teeth' of the plates for fastening; several nails were also used to fasten many of the plates (see Figure 1). The truss plates connecting the bottom of the vertical webbing members to the bottom chords measured approximately 9-1/2" x 13-1/2". The truss plates connecting the top of the vertical webbing members to the top chords measured approximately 5-1/2" x 6". The truss plates connecting the 2x4 webbing members to the chords were not analyzed in detail because they were observed to be in good condition.

Figure 1 – King Post and Top Chord Truss Plate w/ Nails

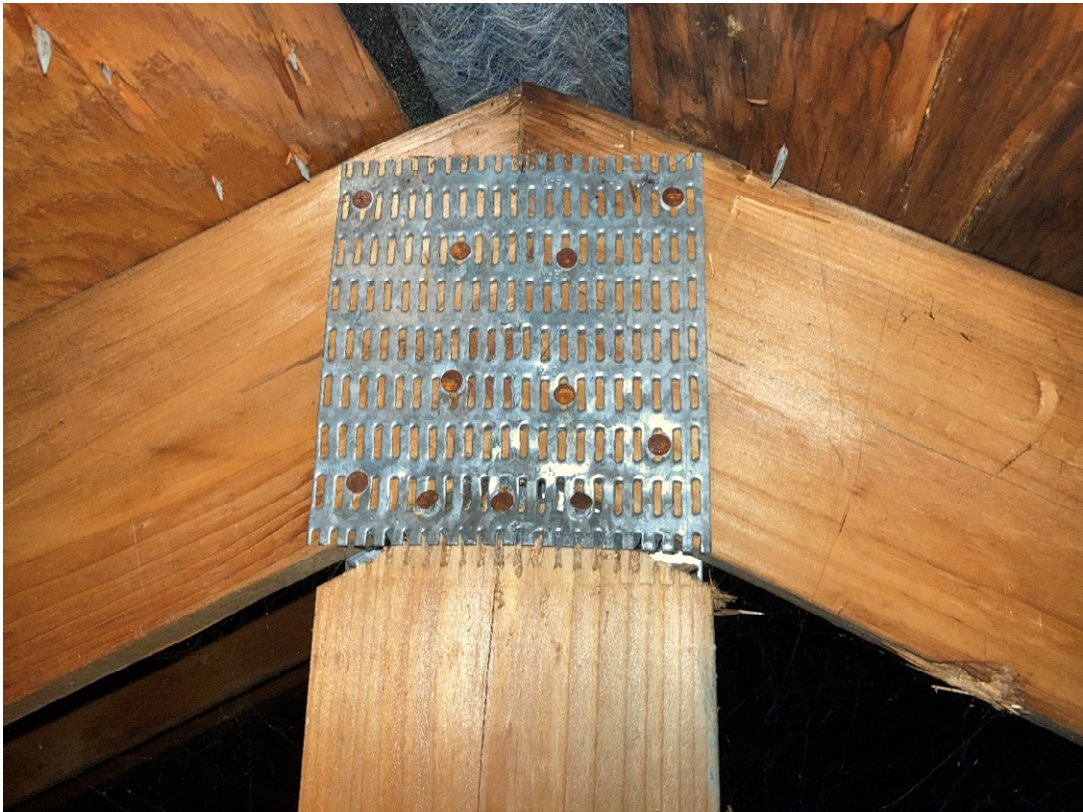
approximately 9 presented signs of significant vertical slippage, with greater than ¼" separation between the vertical webbing members and the top chords. The amount of separation between the vertical webbing members and the top chords varied from 0" to 5/8". See Figure 2.

Because the vertical webbing members have separated from the top chords in situ, after installation, the connections undergoing separation are effectively in a state of failure. The duration of development for the connection failure is unknown; the separation may have developed during a short period of time during a severe climatic event, for example, or it may have developed more slowly, perhaps over the course of the lifetime of the structure. Regardless, it is possible that the connection failure currently observed in 9 of the premanufactured trusses may begin to manifest in the remaining trusses and that, eventually, a catastrophic failure may occur.

The mode of failure is likely the inadequacy of the connection capacity relative to the experienced load.

Figure 2 – Vertical Separation at Top of King Post

- Until a repair has been implemented, remove excess snow to minimize the loads supported by the roof.
- Repair the truss deficiencies using one of the options listed below:

- Replace the truss plates connecting the top of the vertical webbing member to the top chord of all premanufactured trusses.
- Install two additional vertical web members, one on either side of the existing vertical web, for all premanufactured trusses.

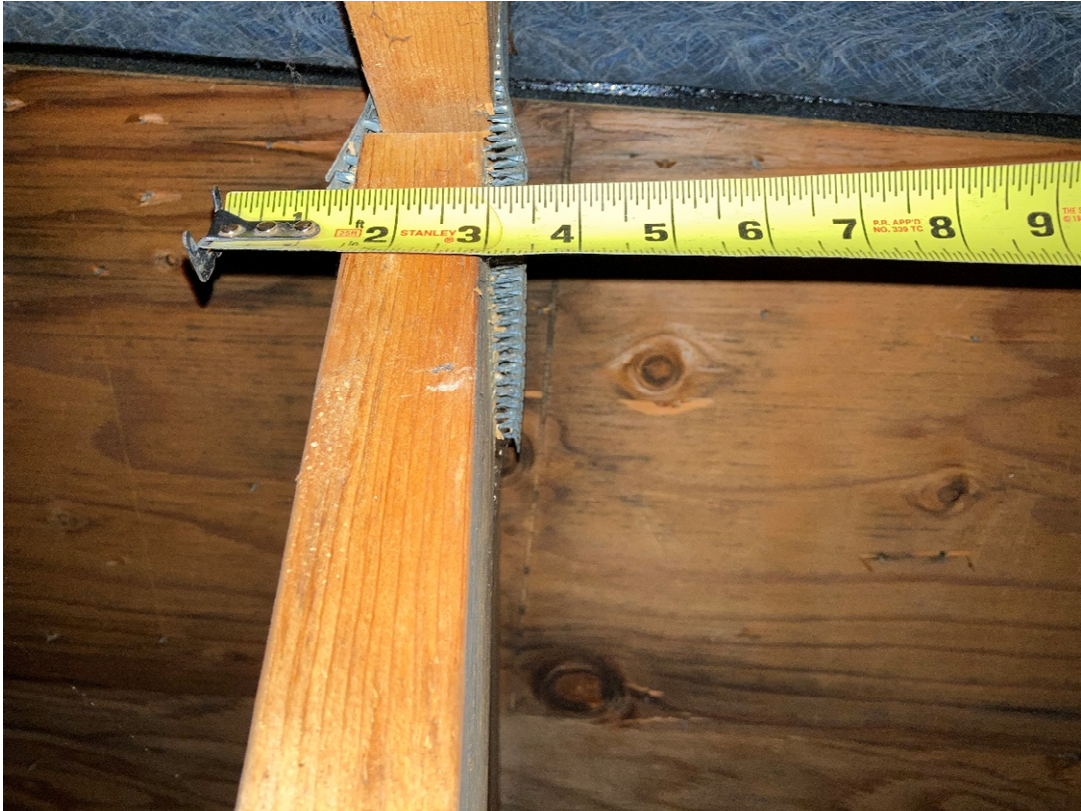
Where vertical slippage had occurred, the truss plates on one or both sides of the vertical webbing members have also laterally separated from the posts, resulting in a loss of plate tooth embedment. The amount of lateral separation between the truss plates and the vertical webbing members varied from 0" to approximately 3/8". It is important to note that, at 3/8" separation, the teeth of the truss plates were fully disengaged from the vertical webbing member. See Figure 3.

Figure 3 – Lateral Separation at Top of King Post

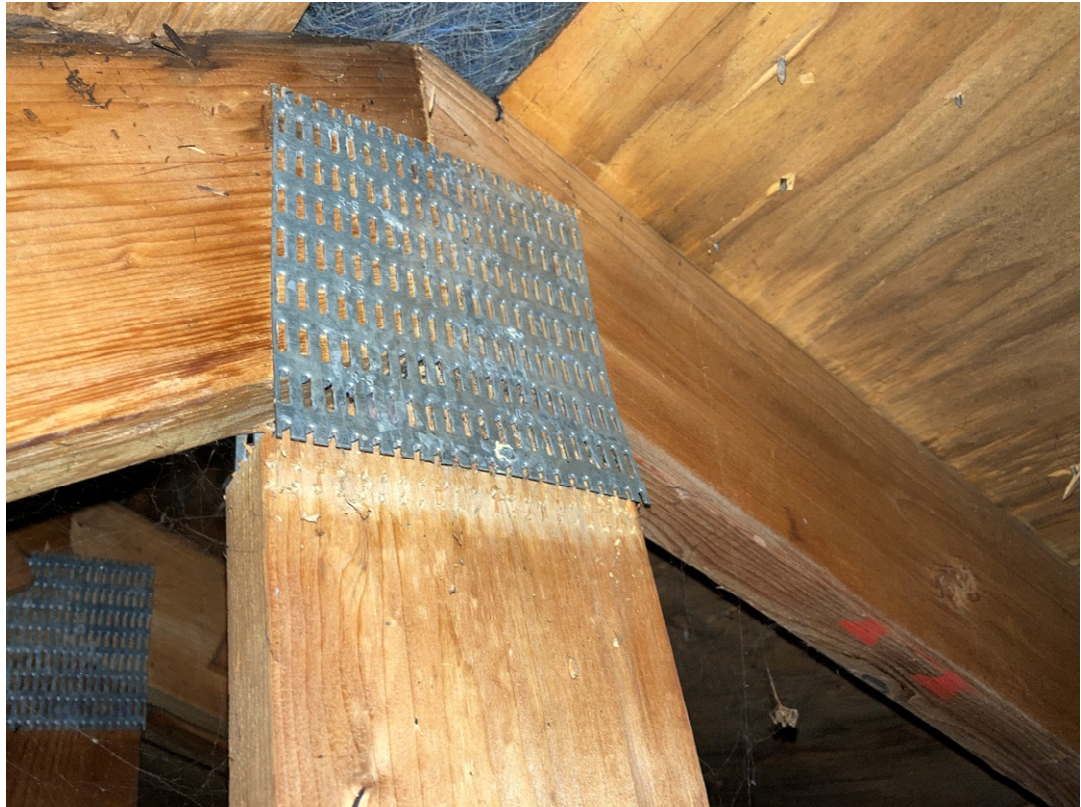
Where the plates were separated from the vertical webbing members, grooves were etched into the surface of the webs indicating that the separation had occurred in situ, after truss assembly. See Figure 4.

Figure 4 – Surficial Scraping from Plate Slippage
